Maryland Inventory of Historic Properties Historic Bridge Inventory Maryland State Highway Administration Maryland Historical Trust

Maryland State Highway Administration  Maryland Historical Trust
SHA Bridge No. 11024 Name: US 219 over Youghiogheny River
Location: Street/Road Name and Number: US 219 (Elkins Oakland Road)
City/Town: Redhouse Vicinity X
County: Garrett
Ownership: X State County Municipal Other
This bridge projects over:RoadRailway_X_WaterLand
Is the bridge located within a designated district: _yes X no
_NR listed district_NR determined eligible district _locally designated_other Name of District
Bridge Type:
Timber BridgeBeam BridgeTruss-CoveredTrestleTimber-and-Concrete
_Stone Arch
_Metal Truss
_Movable BridgeSwingBascule Single Leaf_Bascule Multiple LeafVertical Lift_Retractile_Pontoon
Metal GirderRolled Girder Concrete EncasedPlate GirderPlate Girder Concrete Encased
_Metal Suspension
_Metal Arch
_Metal Cantilever
X Concrete Arch Concrete Slab Concrete Beam Rigid Frame
Other Tyne Name

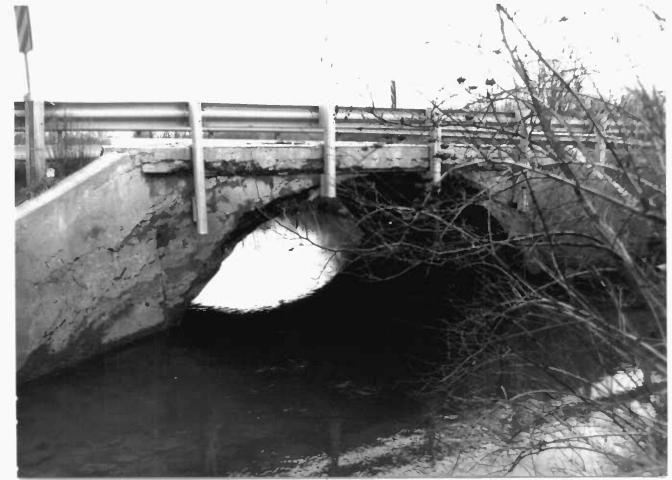
ER# 10/13/1024 G-V-A-179 OVER YOUGHIOGHENN RIVER GARRETI DU MO JAVIZ KING 1/19/95 SHA EAST ELEVATION (UTSIREAM)

In 1927 the original bridge was widened. At an unknown date the 1927 parapet walls were removed and replaced with a guardrail system. The upstream spandrel wall has been repaired with gunite.
